## CASE STUDY: Super-G<sup>TM</sup> Secondary Belt Cleaning System

<b>Kinder Australia Product:</b>	<b><u>Super-G<sup>TM</sup> Secondary Belt Cleaner</u></b>
<b>Product Category:</b>	Belt Cleaning Products
<b>Location:</b>	Queensland
<b>Conveyed Materials:</b>	Timber Planks (Spruce-pine-fir, or SPF)
<b>Conveyor Belt Width:</b>	500mm
<b>Conveyed Belt Speed:</b>	1m/s
<b>Installation Date:</b>	March 2017

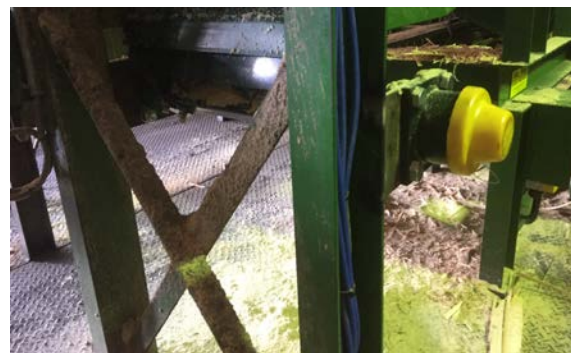
**ABOVE**  
Image of Super-G<sup>TM</sup> Belt Cleaner installed on site.

The **Super-G<sup>TM</sup> Secondary Belt Cleaning System** was accessed and agreed as the best option in addressing the saw mill's belt cleaning challenges. The recommended **Super-G<sup>TM</sup> Secondary Belt Cleaner** was easily installed on the site's laser scanning station due to its ability to utilise a 'pass-through' mainframe design allowing timber plants to freely fall through it, keeping operations running with little to no maintenance resources and waste materials. The Super-G uses the same heavy duty mainframe and Perma-Torque<sup>TM</sup> spring free urethane tensioning system as the Eraser primary belt cleaning system, incorporating a corrosion resistant, fully sealed and dust proof polyurethane tensioner, providing safe, reliable blade adjustment for optimum belt cleaning.

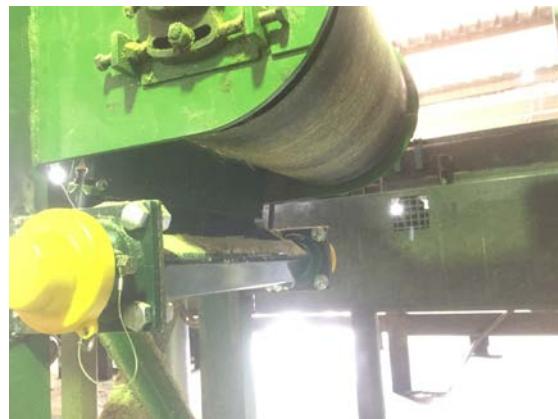
**RIGHT**  
Close up image of Super-G<sup>TM</sup> Belt Cleaner AFTER Installation

Due to the effectiveness and performance of the installed **Super-G<sup>TM</sup> Secondary Belt Cleaner**, the site's conveyor belt is now only cleaned at the end of the day, saving maintenance and labour costs. A cleaner conveyor belt has greatly improved scanner accuracy, thereby minimising the level of material wastage.
