CASE STUDY: Tru-Trac® Conveyor Belt Tracking System

Product:	Tru-Trac® Conveyor Belt Tracking System
Product category:	Conveyor Belt Tracking
Location:	Power Station, Yallourn, Victoria
Conveyed material:	Brown Coal
Conveyor belt width:	1200 mm to 1400 mm
Conveyor belt speed:	4.5 to 5.0 metres per second
Rate:	2400 tonnes per hour
Installation date:	4 years ago, 2010

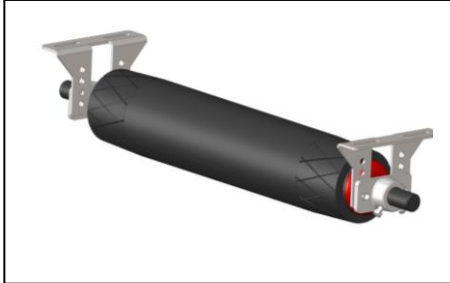
Above: Image of the Tru-Trac® Conveyor Belt Tracking System - the range covers self-aligning idlers for tracking both the return and load-carrying sides on slow moving, reversible, high-speed and high-load belts up to 2500mm.

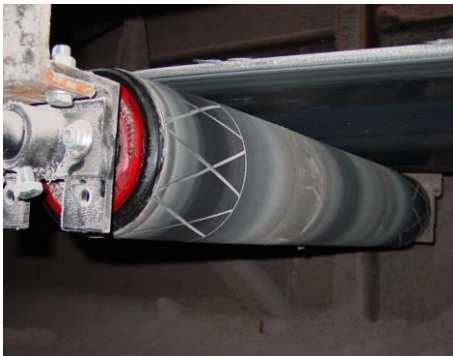
Below: Tru-Trac® Conveyor Belt Tracking System installed.

"I had previously used Tru-Trac® idlers before and decided to trial one on our worst conveyor. I removed the inverted vee and then installed the Tru-Trac® in the same spot which was upside down to the normal fitting method.

It was an immediate success. I trialled it for 3 months and then bought another 3 for the remaining spill conveyors. I installed them in exactly the same location and in the same manner and I no longer have any belt tracking issues at all. They have been in use now for 4 years and I have not had to touch them."

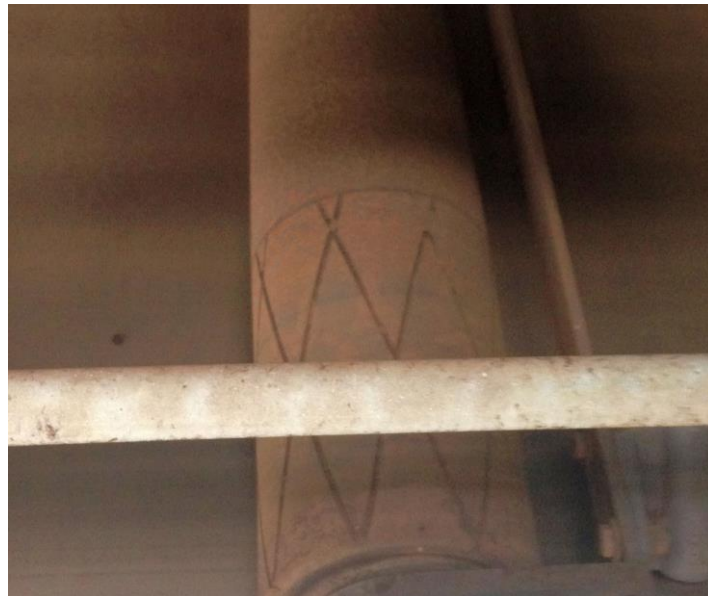
Right: Tru-Trac® customised installation at the Power Station.

Our customer is delighted with the decision to install the Tru-Trac® Conveyor Belt Tracking System. It has met our customer's expectations and solved their **immediate belt tracking issues**. After 4 years of continuous use, the Tru-Trac **reliably keeps the belt tracked "true" and has required no adjustments to maintain the correct belt alignment**. The outcome is that material spillage is successfully avoided and clean-ups are not necessary.
