CASE STUDY: K-Shield Impact Belt Support System

Kinder Australia Product:	<u>K-Shield Impact Belt Support System</u>
Product Category:	Conveyor Belt Support
Location:	Bunbury, Western Australia
Conveyed Materials:	Hard Rock - Basalt
Conveyor Belt Width:	1050 Belt Width
Installation Date:	July 2017

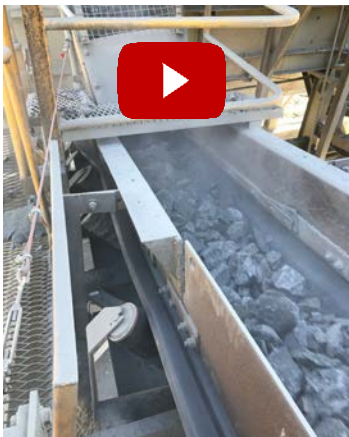
LEFT
BEFORE K-Shield Impact Belt Support

- Conveyor belt damage, including several belt failures leading to major production losses.
- Frequent premature roller failures.
- Material spillage issues.
- Escalating belt repair, replacement and maintenance costs

Kinder Applications Team observed and reported “transfer points were incorrectly located in the transition zone, this factor contributed to premature conveyor belt and trough roller failures, due to the high tension”. With an unsupported conveyor belt within the critical loading zone, conveyed rock material could be seen bouncing along the conveyor belt and ejecting onto the nearby walkway. Material spillage left uncontained was reportedly causing manual handling requirements in the form of cleaning by site maintenance and production teams.

To address the major concerns observed at the initial site inspection, Kinder Applications Team proposed installing the K-Shield Impact Belt Support System, specifically to improve material containment at high impact transfer points on the conveyor belting system.

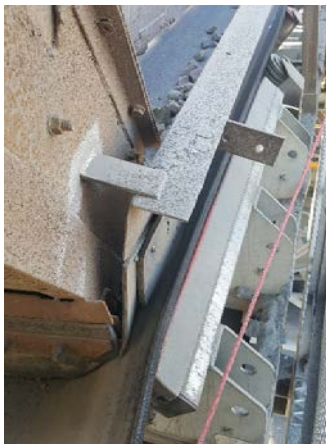
The K-Shield Impact Belt Support System is a custom engineered solution delivering extra support under the moving conveyor belt. By providing a continuous trough profile and helping to stabilise the load at the transfer point, the solution ultimately reduces material spillage and manual handling.

Within four months, the cost of the K-Shield Impact Belt Support System installation was literally paying for itself, with a reduction in conveyor belt replacements and repairs, which would've cost \$5,372.85. The Quarry Manager was also pleased to report the new conveyor belt is still in excellent condition and functioning at maximum productivity.
