Case Study – K-Cleanguard Belt Pre-Cleaner

Kinder Australia Product:	<u>K-Cleanguard Belt Pre-Cleaner</u>
Product Category:	Conveyor Belt Cleaning
Location:	Antofagasta, Chile
Conveyed Materials:	Leached copper ore
Conveyor Belt Width:	1829mm
Production Capacity:	6.2 m/s, 9.000 tonnes per hour

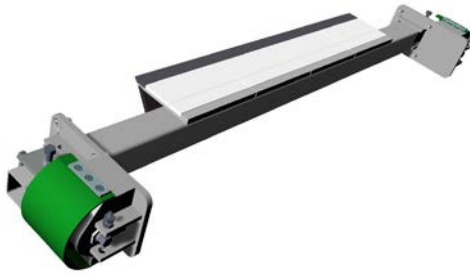
K-Cleanguard Belt Pre-Cleaner

We recommended installing **K-Cleanguard Belt Pre-Cleaners** at the discharge of every conveyor, focused on separating the main ore flow of the conveyor belt and extending the wear life of the primary belt cleaner's blade. A special pre-cleaner wear plate had to be designed for Antucoya's operation, since their condition was even more severe than others experienced before, using the most resilient materials available.

After installing the **K-Cleanguard Belt Pre-Cleaners** the client was able to extend the wear life of the primary cleaner's blade by a factor of 14. This allowed for two weeks between blade replacements (improving over a job that was done on a daily basis), drastically reducing man-hours and worn blades, and furthermore allowing replacements to take place during normal scheduled maintenance downtimes.

The **K-Cleanguard Belt Pre-Cleaner's** specially designed wear plates also showed an exceptional wear life of 45 days in these conditions, where regular pre-cleaner wear plates would barely have lasted a week.
