## Case Study – K-Sure® Belt Support System

| <b>Kinder Australia Product:</b> | <b><u>K-Sure® Belt Support System</u></b> |
| <b>Location:</b> | Geraldton, Western Australia |

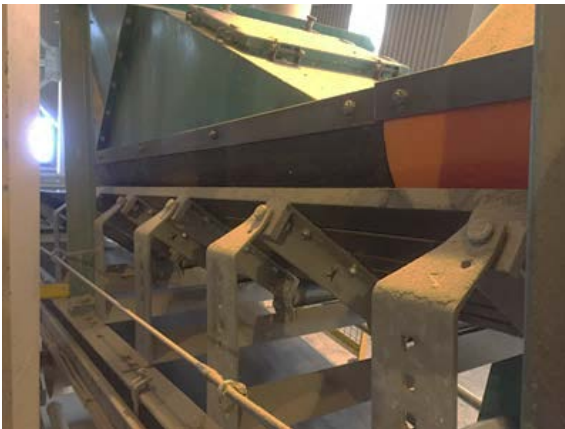
### PICTURED LEFT

*Inspection 05/02/2020, 6 years after the installation was completed back in early 2014.*

**In 2020, six years after initial installation, a follow up inspection of the K-Sure® Belt Support System revealed minimal wear. With extremely positive results, the site is now looking at utilising this technology on other transfer points within the export terminal.**

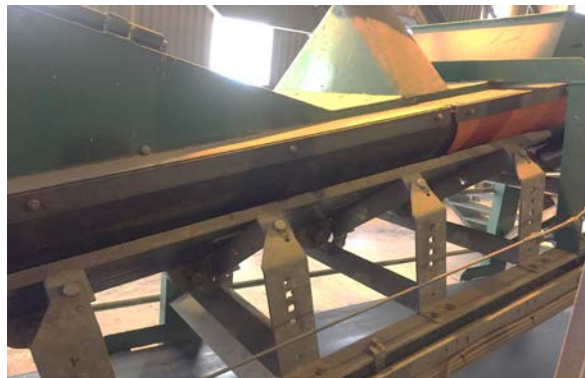
**The maintenance team observed immediate positive results from the K-Sure® Belt Support System installation.** The grain operation has achieved a significant reduction in material spillage at the transfer point. The problems of pest/rodent contamination, associated hygiene issues and dust emission has been greatly minimised due to spillage reduction. Improved material flow has resulted in minimal production downtime. Cleaning up time and maintenance resources around the transfer point is no longer required.
