Case Study – K-Sure® Belt Support & K-Snap-Loc® Dust Seal System

Kinder Australia Product:	K-Sure® Belt Support System & K-Snap-Loc® Dust Seal System
Product Category:	Conveyor Skirting & Transfer
Location:	Toowoomba QLD
Conveyed Materials:	Blended Fertiliser Materials
Conveyor Belt Width / Speed:	700mm Belt Width / 1m/sec
Rate:	5000 tonnes per season
Installation Date:	January 2022

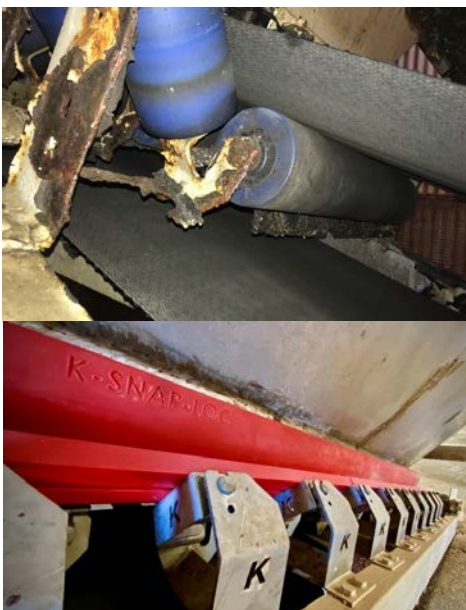
Steel idler frames with plain rubber soft skirting was mostly used as the plant's primary line of support within the transfer point areas. It was clear from site inspections high humidity environment and atmosphere generated within the hopper from blended materials was a key contributor to significant rust and corrosion damaging critical plant and equipment.

Corrosive rust present on the idler frames was so severe the frames were ready to collapse, the potential to cause production havoc and short-term shutdowns was a constant concern for the operator. Belt sag between the idlers was also identified as a key area for rectification. The material being loaded was not adequately supported. This caused skirting to lift away from the belt line resulting in major spillage and product loss. 1 tonne of product each season was written off, plus additional maintenance and cleaning up costs was factored in to remove material spillage.

Photos: The presence of corrosive rust caused conveyor componentry damage; idler frames were on the verge of collapse (Top). After Installation of K-Sure® & K-Snap-Loc® (Bottom).

K-Sure® Belt Support System was very easy to set-up and tune to the belt's existing profile. Stainless steel idlers were installed together with the K-Sure® Belt Support System to deliver solid belt support where it was most needed. The installation of stainless steel (SS-304 grade) idler frames and brackets also part of the solution ensured the issues of corrosion/rust and conveyor componentry damage won't be a concern in the foreseeable future.

K-Snap-Loc® Dust Seal, skirting system was installed specifically to address material spillage and spiralling product loss. Once the K-Snap-Loc®'s mounting system was welded into place, the soft skirt was hassle free to fit.

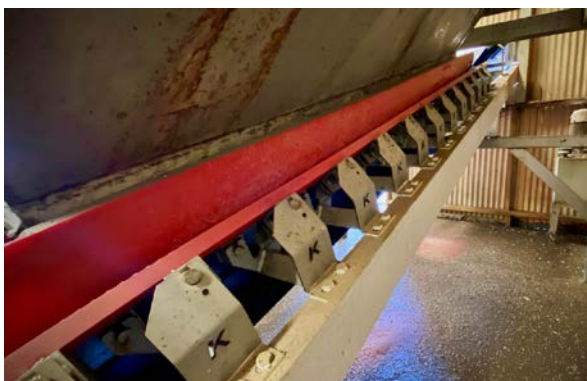
Photos:

After installing K-Sure® Belt Support System (L) & K-Snap-Loc® Dust Seal System (R).
