# Case Study - K-Conveyor Pulley

**K-Conveyor Pulley**

**Conveyor Pulleys & Lagging**

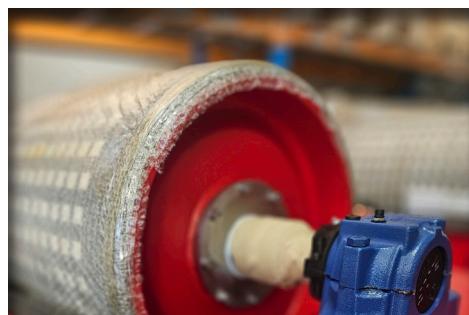
K-Conveyor Pulleys packed and ready for shipment to our Mining client.

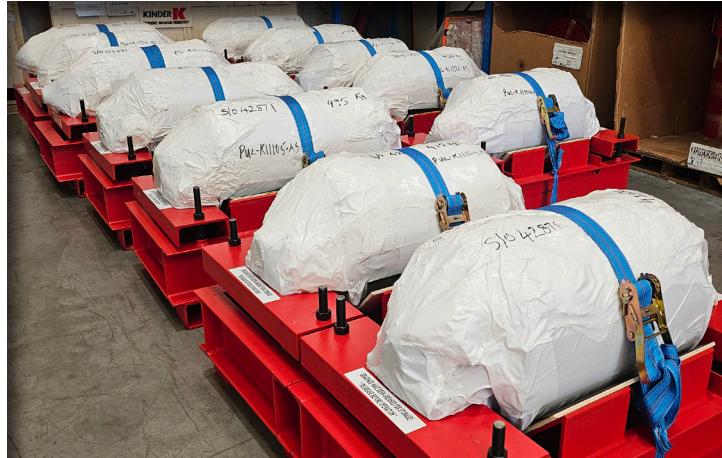
K-Conveyor Pulleys packed and ready for shipment to our Mining client.
