**Kinder Australia Product:**

**K-Superline® Engineered Polyurethane**

**Northern Territory**

***Zero Blockages. 18+ Month Liner Life. Once-Yearly Maintenance.***

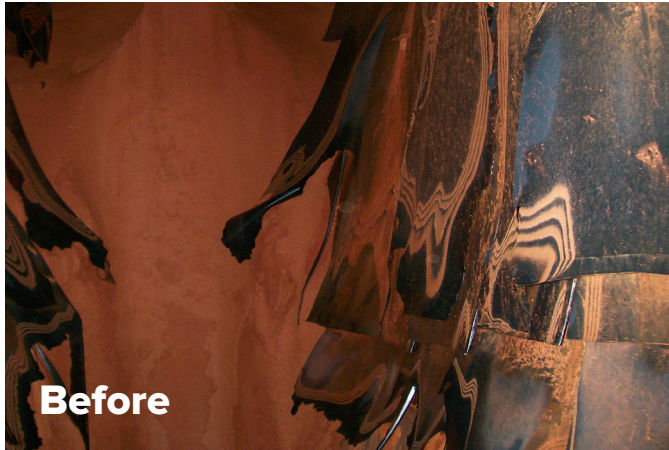
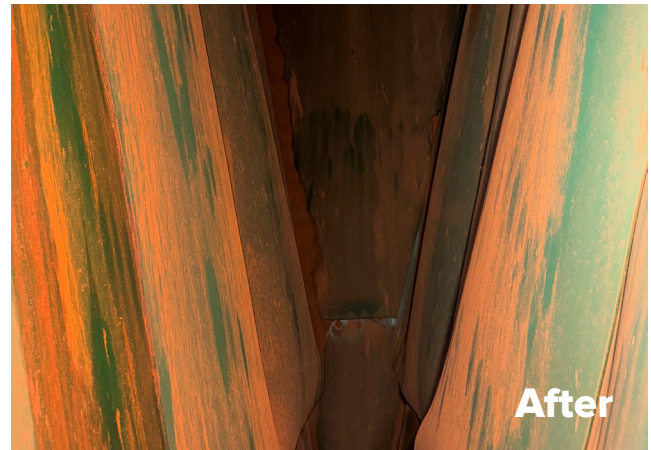
The proposed system incorporated customised hanging polyurethane wear curtains designed to promote continuous, smooth material flow through the discharge chute. Their low-friction surfaces prevented the formation of buildup, while the embedded chains mounting system enabled rapid liner replacement without requiring full chute access. The thin and flexible curtains were able to be rolled into a tight package that could be manually transferred through the small 800x800mm opening, while the high abrasion resistance of the K-Superline® meant that the lightweight and thin curtains would handle the high throughput of the chute. Each component was engineered to the site's specific wear patterns, ensuring optimal performance and significantly extended liner life. **K-Superline® incorporates an integrated dual-colour wear indicator to allow rapid and precise visual monitoring of wear performance.**

By removing the root cause of material hangup and delivering a long-lasting, easily serviceable solution, Kinder's K-Superline® system has transformed a major operational bottleneck into a reliable, low-maintenance asset. The flexible hanging curtains maintain consistent material flow, while the engineered polyurethane construction ensures exceptionally long wear life.
