# Success Story

## Quarry Rock - Magnetic Separation

| <b>Kinder Australia Product:</b> | <b>K-Magnetic Separator Pulley</b> |

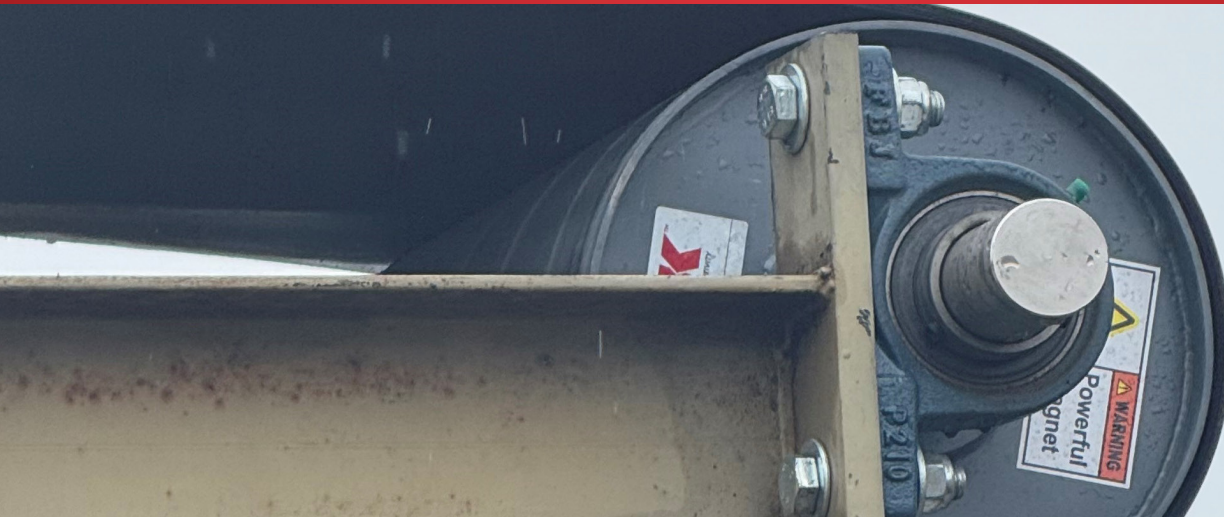
| <b>Conveyed Materials:</b> | <b>Sand and 7mm Stone</b> |
| <b>Conveyor Belt Width:</b> | <b>750mm BW - 1.44mps</b> |

The installation of the K-Magnetic Separator Pulley delivered immediate benefits. Iron contaminants are now efficiently removed before the mixing stage, preventing rust formation and ensuring clean, high-quality aggregates. As a result, finished blocks, pavers, and tiles maintain a consistent, stain-free appearance that meets customer expectations.

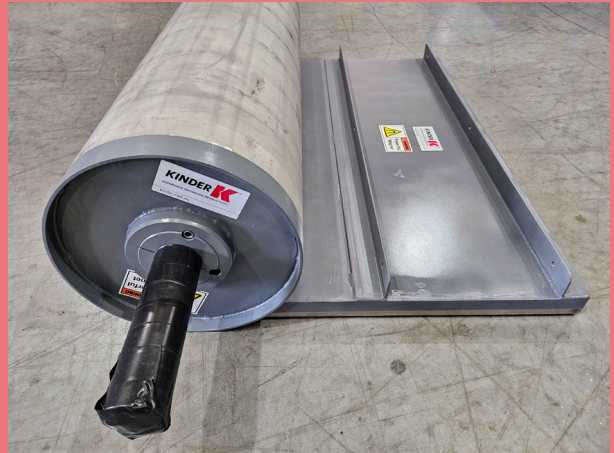
Photo: K-Magnetic Separator Pulley and Take Off Rail.

To eliminate the contamination issue, the manufacturer upgraded their conveyor system by installing Kinder's **K-Magnetic Separator Pulley**. This specialised pulley integrates powerful magnets into the head drum, allowing it to continuously capture and remove iron particles from the material stream. As aggregate passes over the pulley, non-magnetic stone and sand flow freely, while metallic contaminants are automatically extracted and separated.

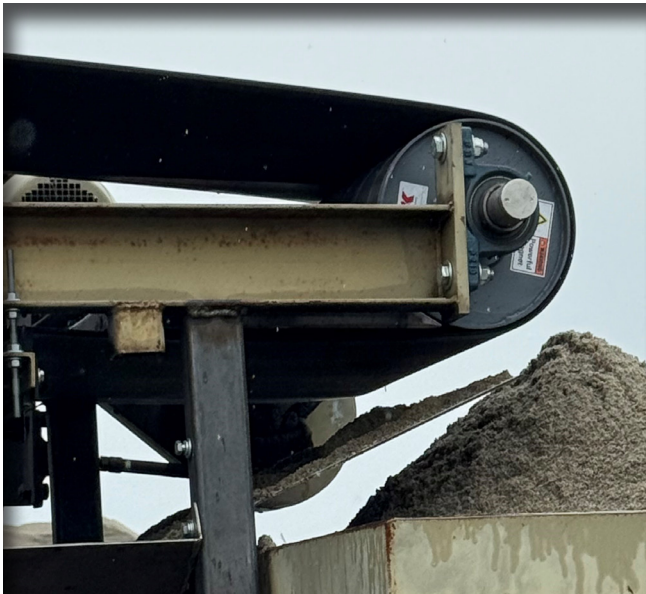
Photo: K-Magnetic Separator Pulley installed at the head drum.
