CASE STUDY: K-Sure[®] Belt Support & K-Ultra Dual[®] Seal

Kinder Australia Products:	K-Sure [®] Belt Support System & K-Ultra Dual [®] Seal
Product Category:	Conveyor Belt Support
Product:	Fired Limestone Powder
Production Rate:	200 tonnes per hour
Belt Speed:	1 metre per second

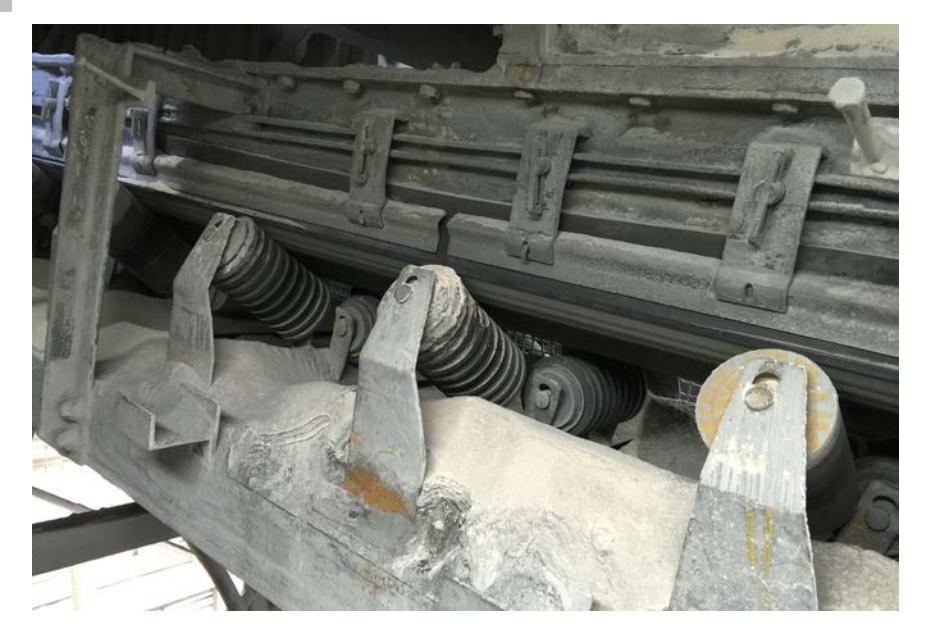
Our customer was experiencing significant product spillage issues causing the trough rollers at the transfer point to seize and wear out prematurely, **pictured here below**.

This is a common problem experienced at transfer points where the force of the conveyor feed through a drop chute from another conveyor, causes **belt edge sag** in between belt supporting rollers. Not only is there spillage, but the skirting arrangement present wears prematurely and a dust hazard is created.

Belt Edge Sag: The weight pressure of the transferred material load causes the conveyor to sag in between the supporting idlers.

The problem was effectively resolved by replacing the existing impact wing rollers under the transfer chute with our, **K-Sure® Belt Support System**. This belt support configuration utilises a series of low friction polymer slider bars. K-Sure® Belt Support's universal adaptor brackets are then arranged to the existing frame and assembled precisely to suit the conveyor's troughed belt profile.

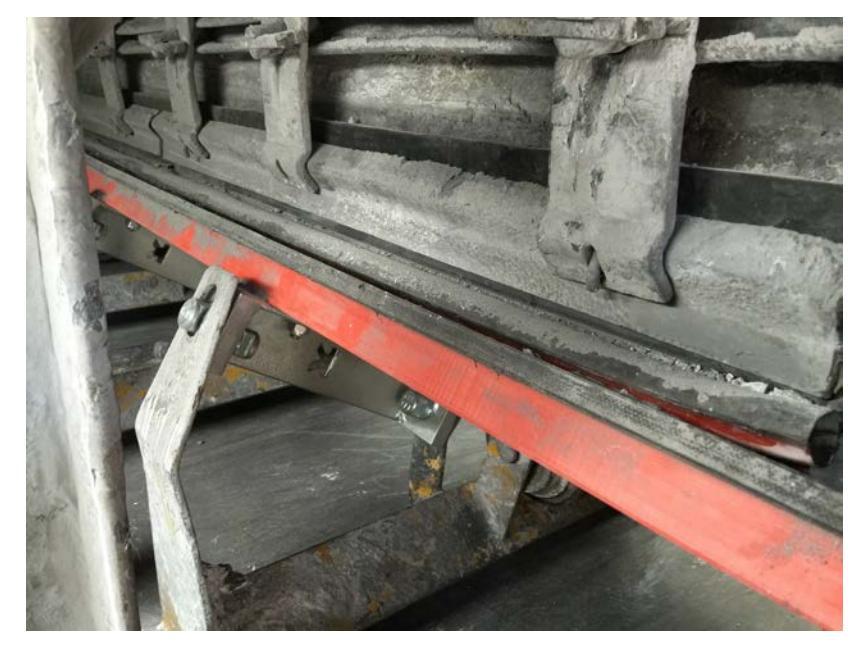
Pictured here is the spillage-free transfer point area, the Kinder "K" universal bracket's, K-Sure® Support's red polymer slider bars. K-Ultra Dual® Seal was pre-existing, but now functions as it was intended and controls dust particles from becoming airborne.

The System requires no pre-engineering, adjustments or special tools and the outcome has successfully removed the occurrence of belt sag. Now there is no spillage to clean-up, and the already present K-Ultra Dual[®] Seal can effectively contain the blow-out pressure of the dust particles.

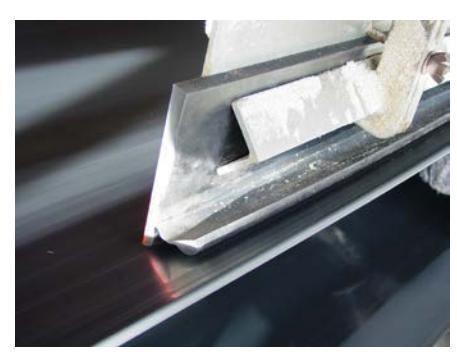
Image below to show K-Ultra Dual[®] Seal in operation.
