CASE STUDY: Material Containment & Dust Control

Kinder Australia Products:	<u>K-Containment Seal & K-Snap-Loc® Dust Seal System</u>
Product Category:	Conveyor Skirting & Transfer
Site Location:	South-Western Victoria
Conveyed Material:	Wood Chip
Location on Conveyor:	Transfer Conveyor Tower
Installation Date:	January 2016

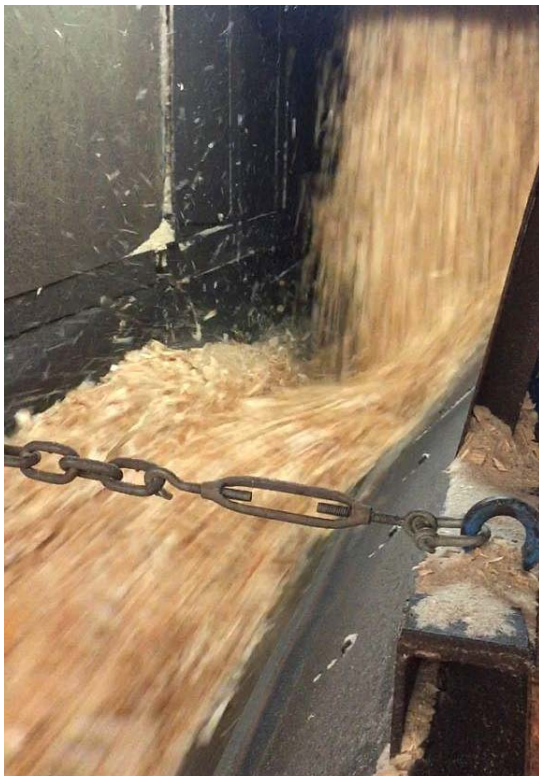
This was the problem that our wood chip customer was experiencing. The Maintenance Supervisor had estimated that the spillage was costing the company approximately \$2000 each week to clean-up and take away.

Photo showing the material flow at transfer conveyor tower and surrounding wood chip spillage.

Kinder Australia recommended the installation of K-Containment Seal to effectively contain the bulk wood chip material and handle the high internal chute pressure.

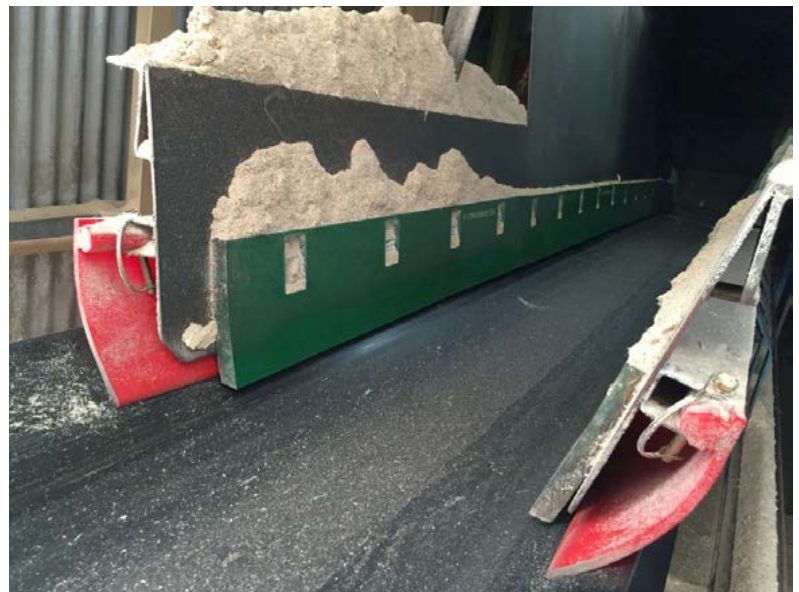
Photo showing the combined installation of K-Containment Seal with the height adjustable slots, together with the simple unistrut mounted K-Snap-Loc®.

K-Containment Seal is a high performance, low friction engineered polyurethane system that provides exceptional resistance to wear. The slotted arrangement allows for installation adjustment to ensure that material cannot be entrapped leading to premature belt damage.

The K-Snap-Loc® Dust Seal System was also installed in combination with K-Containment Seal. This strong and very pliable polyurethane's inherent “memory-set” applies efficient downward pressure on to the belt's surface to create a fine tight seal without the need for any further manual adjustment.
