CASE STUDY: K-MotorShield Motor Covers

Product:	<u>K-MotorShield Motor Covers</u>
Product category:	Safety & Environmental
Location:	Maryvale Mill, Traralgon, Victoria
Material application:	Pulp
Installation date:	July 2011
Number installed:	14

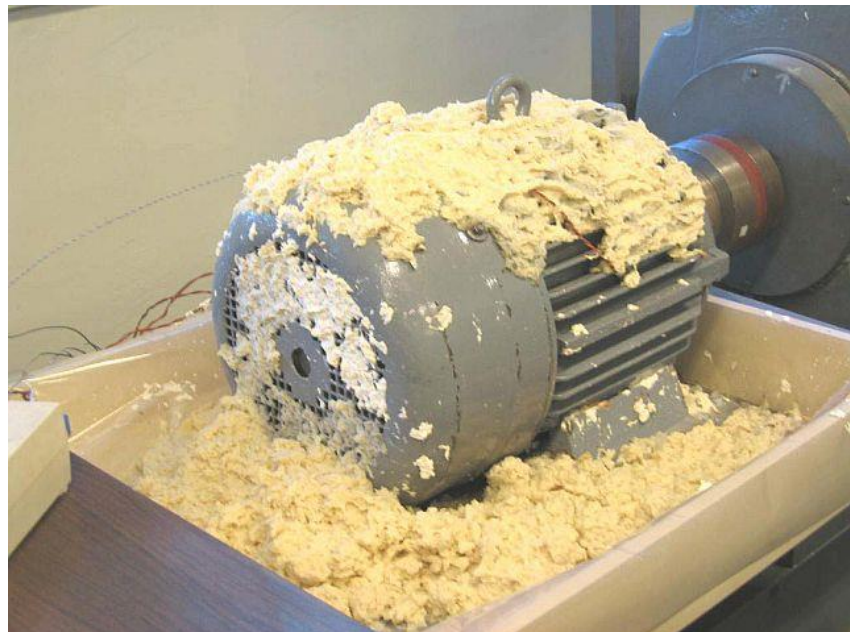
Set in a laboratory, photo example of pulp clogging the motor

“Previously we didn’t have any sort of cover for our motors and because of the high spillage rates, we were experiencing regular winding failures, bearing failures as well as counter-productive high motor temperatures, all due to the constant pulp contamination on our motor frames and the air intakes. Maintenance stops were becoming time-consuming and costly.”

They have been very effective in minimising the pulp getting in the end covers and clogging up the fins that was causing the previous overheating problems. I can already predict significant cost savings for the Mill in terms of money spent on the maintenance and repairs of the motors.
