# Success Story

## Quarry - Dust, Spillage, Carryback & Asset Protection

**Various Conveyor Componentry Solutions**

**Belt Cleaning, Skirting, Support, Idler Frames & Covers**

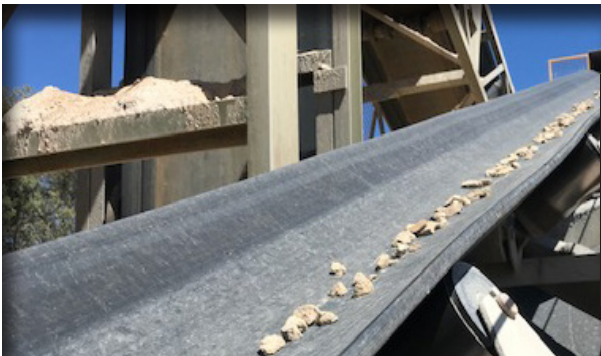
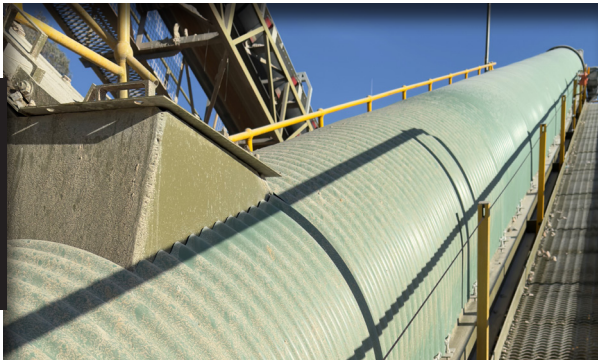
Before (left) and After (right) K-AllShelter® Conveyor Covers installation.

| PROBLEM SOLVED | KINDER SOLUTION | BENEFITS |
|---|---|---|
| | K-AllShelter® Conveyor Covers | Custom-painted to match the natural surroundings, these covers protect materials from weather and reduce visual impact for the local community. |

The custom-painted K-AllShelter® Conveyor Covers blended seamlessly into the surrounding landscape, reducing visual impact and addressing community concerns about industrial expansion. Improved dust control helped the quarry meet environmental compliance standards and demonstrated a commitment to sustainable operations.

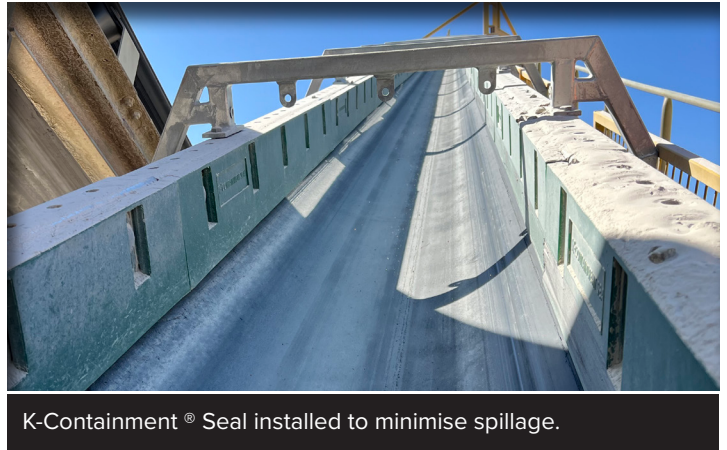
K-Containment® Seal installed to minimise spillage.

| PROBLEM SOLVED | KINDER SOLUTION | BENEFITS |
|---|---|---|
| | K-Containment® Seal | Prevents material from escaping the belt path, minimising spillage and enhancing workplace safety. |

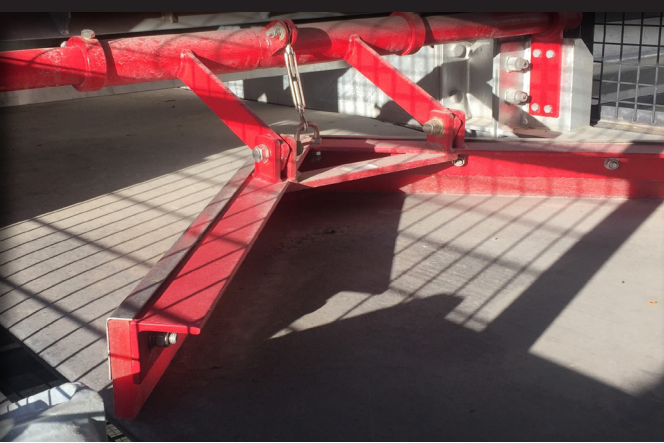
K-Safeguard Vee Plough Belt Cleaner helps clear debris.

| PROBLEM SOLVED | KINDER SOLUTION | BENEFITS |
|---|---|---|
| | K-Safeguard® Vee Plough Belt Cleaner | Clears debris from the return belt before it reaches the tail pulley, protecting critical components from damage. |

Carryback was virtually eliminated, thanks to the Eraser™ Primary Belt cleaner and K-Safeguard Vee Plough System, which reduced roller build-up and extended equipment life. Maintenance demands dropped sharply, with belt cleaners and seals operating continuously without requiring changeouts or frequent servicing.

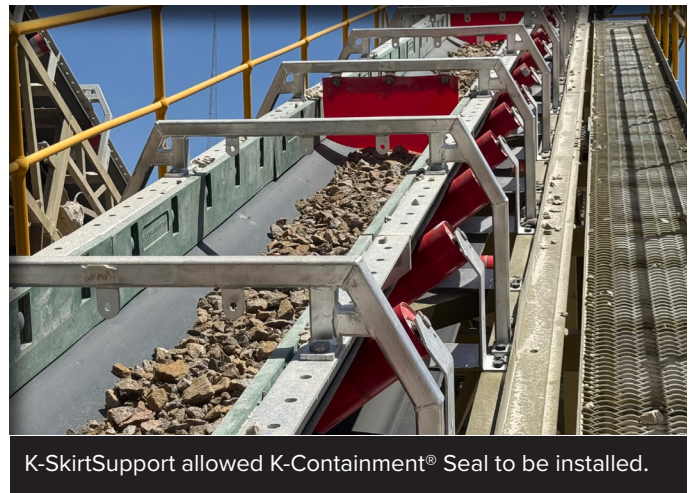
K-SkirtSupport allowed K-Containment® Seal to be installed.

| PROBLEM SOLVED | KINDER SOLUTION | BENEFITS |
|---|---|---|
| Asset Protection | K-SkirtSupport® System | Provides continuous support to K-Containment® Seal on inclines, preventing rollback and fugitive material loss. |
