**Kinder Australia Product:**

**Eraser<sup>TM</sup> Primary Belt Cleaner**

**Conveyor Belt Cleaning Product**

**750 to 1200 BW | 1.5m/s | 200 TPH**

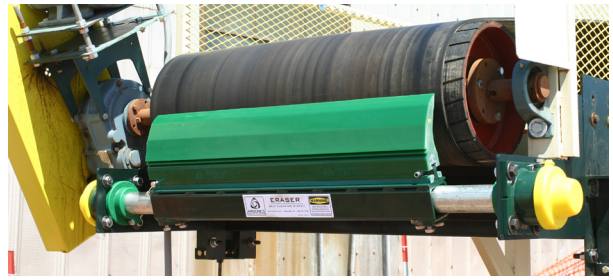
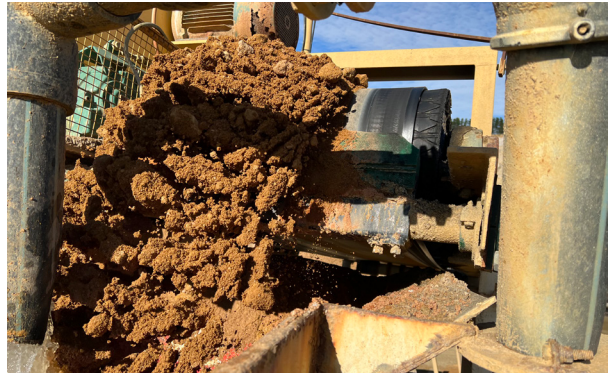
Designed to provide effective carryback control while simplifying maintenance requirements, the Eraser™ Primary Cleaner incorporates a robust polyurethane blade and engineered tensioning system that allows operators to quickly achieve and maintain optimal cleaning pressure.

The simplicity of the Eraser™ design also transformed ongoing maintenance requirements. The straightforward tensioning and maintenance design significantly reduced the complexity associated with cleaner adjustments, inspections, and blade replacement activities.

Kinder's technical team worked closely with site personnel throughout the installation process to ensure correct setup and commissioning. The installation was completed efficiently, with site personnel describing the process as a swift operation supported by practical technical guidance.
