**K-Superline® Engineered Polyurethane B93 / G83**

**Screen Discharge Chute**

***K-Superline®: 2x Wear Life. 50% Faster Change-Outs. Zero Hot Work.***

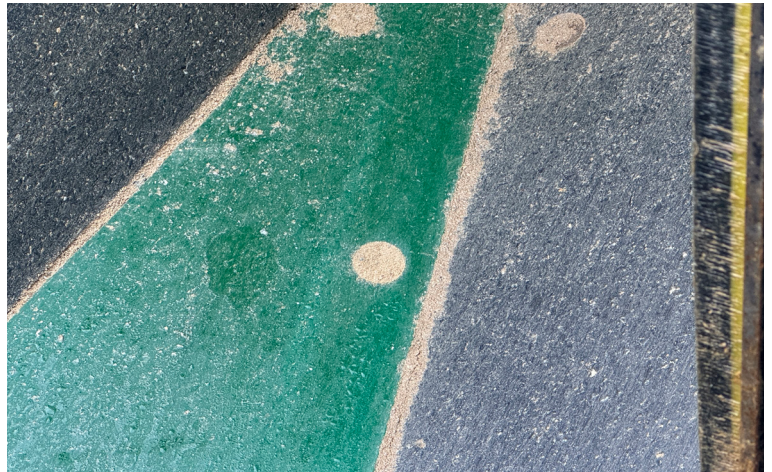
Engineered for severe abrasion and impact applications, K-Superline® B93 provides outstanding wear resistance while its resilient polyurethane construction absorbs impact and resists premature wear in high-load chute environments. The lightweight liners are easily fabricated on site using conventional tools, eliminating the need for cutting, grinding or welding. By removing hot work from the installation process, the solution significantly improved maintenance safety while reducing labour requirements and change-out times.
